## Station Firmware Upgrade – 5.74

Firmware **5.74** has now been released for BS7 and BS8 stations (these include all SPORTident stations with an LCD display). The new version increases the performance of SPORTident stations by improving the data transfer processes and also manages the power consumption correctly in start/finish/clear/check mode when stations are used with SI-Cards 8 and 9. The version of firmware in a station can be checked by dipping the Service/Off key in the station and viewing the settings on the station's LCD display or by reading the station using the SI-Config software.

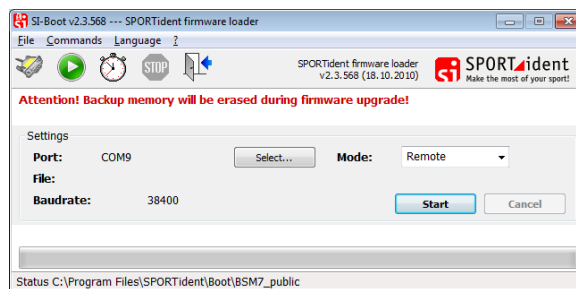
1. Ensure the Program is set to **Remote** to upgrade a Slaved station or **Direct** to upgrade the Masterstation attached to the computer.
2. To upgrade a slaved station, turn the station on using the Service/Off Key and mate it in the usual way with the Master/Printout station.

3. Click on either Start Update button

. Please note that the backup memory in the station will be cleared during the upgrade.
4. The program will automatically select the correct upgrade for the station. Contact us if the upgrade is **NOT** to version 5.74.

5. The end of the update process is signalled by two beeps.
6. Click OK and then **PLEASE WAIT** for a few seconds while the station clock is set to your PC Time. The Firmware Upgrade is then complete and you can remove a slaved station.

SiBoot Software

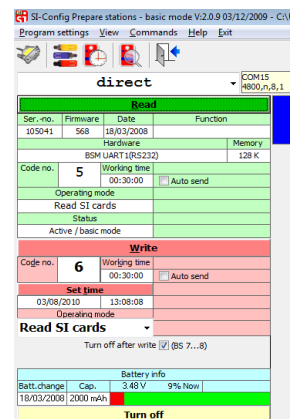
When you have finished upgrading all your stations, please close SiBoot and open Si-Config. Ensure the programme is set to 'Direct' and then 'Read' the station. The box beside the 'Direct/Remote' option will show the baud rate. If necessary, reset it to correct speed by using the 'Commands' menu.

Si-Config Software

If you are using an RS232 Master station or a Print Station with SiBoot, the baud rate (speed of data transfer) will have been changed to 38,400 baud during the firmware upgrade in order to accelerate the process. These stations are normally used at 4,800 baud. The SiBoot software will reset the baud rate back to original speed. However, if any of the upgrades have been interrupted this may not happen correctly.
